**DYNAMIC TESTS
ON
WOOD - NAIL JOINTS**

INTERIM REPORT NO. 2

DYNAMIC TESTS ON
WOOD-NAIL JOINTS

A JOINT TESTING PROGRAM CONDUCTED BY THE
MILITARY TRAFFIC MANAGEMENT COMMAND AND
US ARMY MATERIEL DEVELOPMENT AND READINESS
COMMAND.

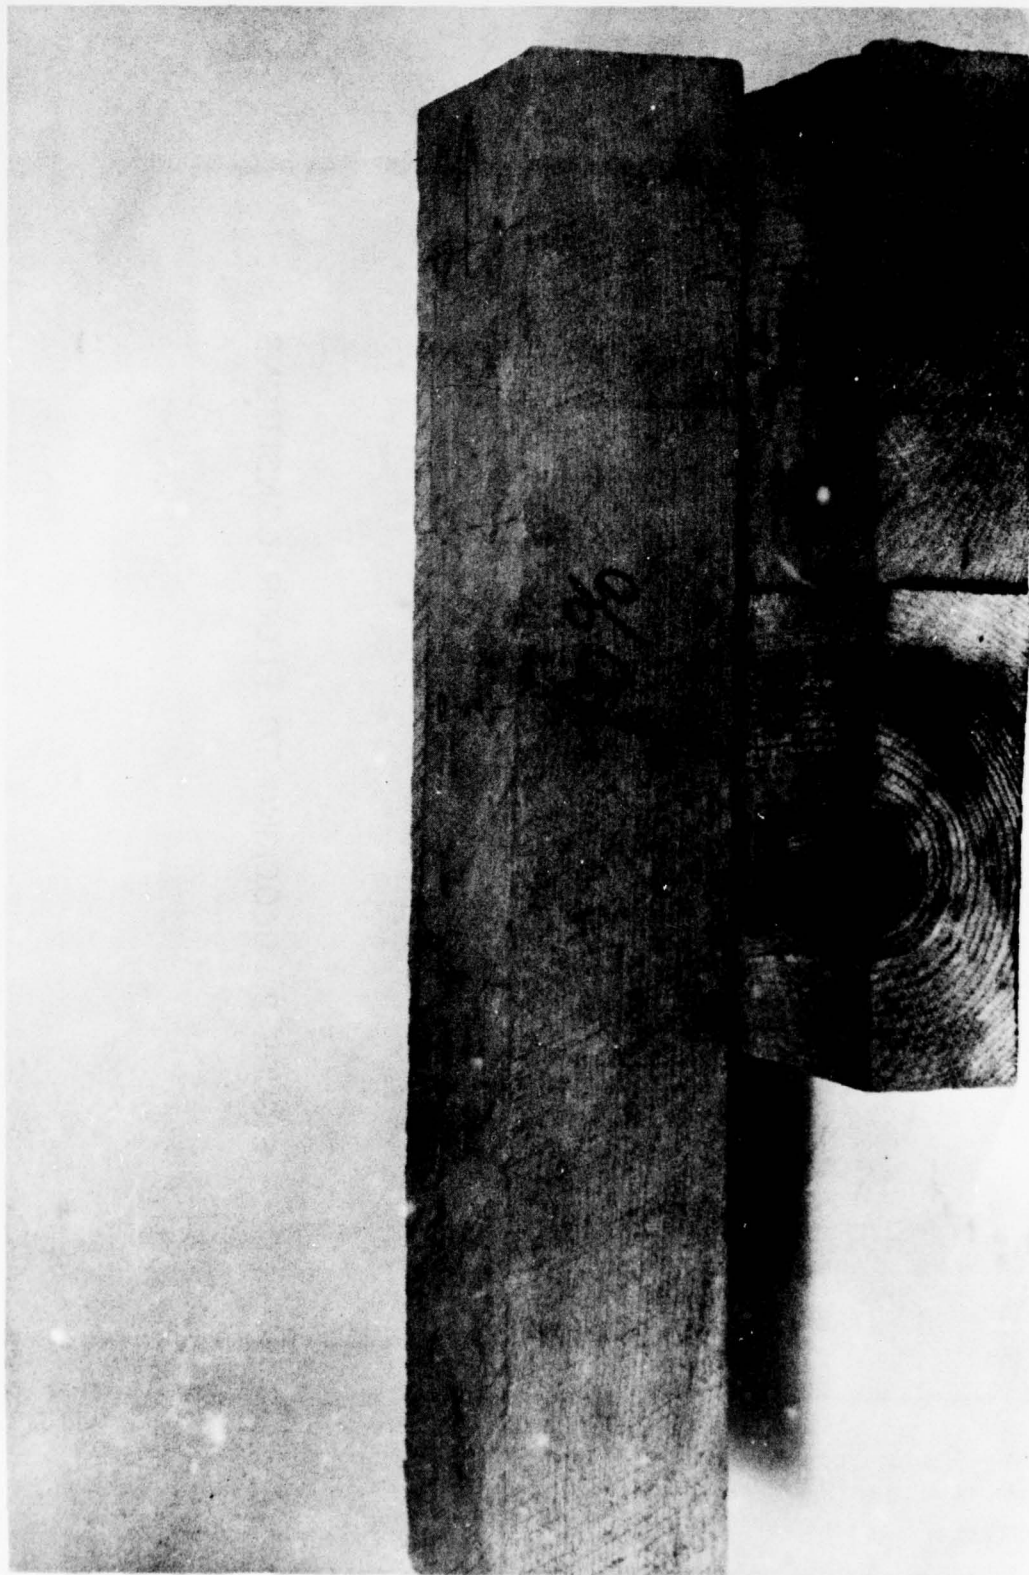
Figure 1

This floor-nail-cleat assembly was used in the X-Ray Test.

The configuration selected for the sequential X-ray test is shown in Figures 1 and 2. Other information is as follows:

Blocking Material or Cleat	Oak
Moisture content	10%
Simulated Floor	Oak
Moisture content	8.5%, 8.25%
Nail Quantity - Size	3 - 50d
Shank	Plain
Material	Low carbon steel
Finish	Bright
Orientation	Vertical
Floor penetration	2-1/4 inch

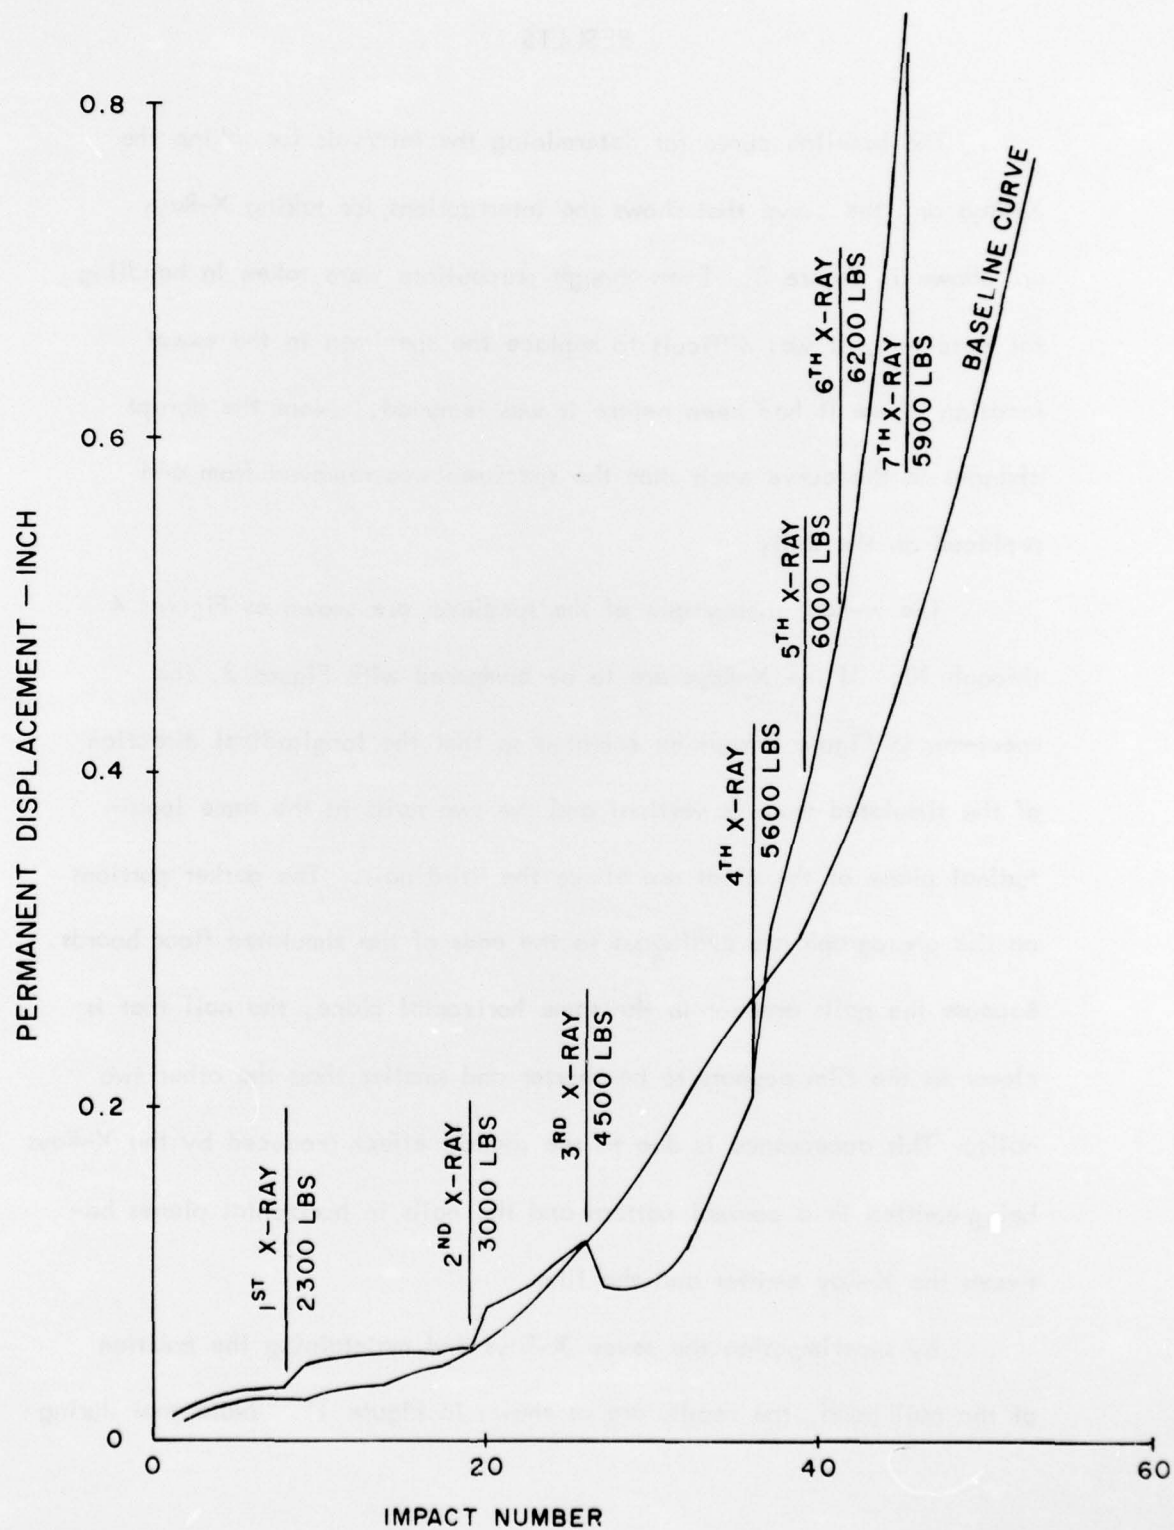
FIGURE 3. DISPLACEMENT AND FORCE SUSTAINED BY SPECIMEN WHEN X-RAY PHOTOGRAPH WAS PRODUCED.

The baseline curve for determining the intervals for taking the X-Rays and the curve that shows the interruptions for taking X-Rays are shown in Figure 3. Even though precautions were taken in handling the specimen, it was difficult to replace the specimen in the exact location where it had been before it was removed. Note the abrupt changes in the curve each time the specimen was removed from and replaced on the dolly.

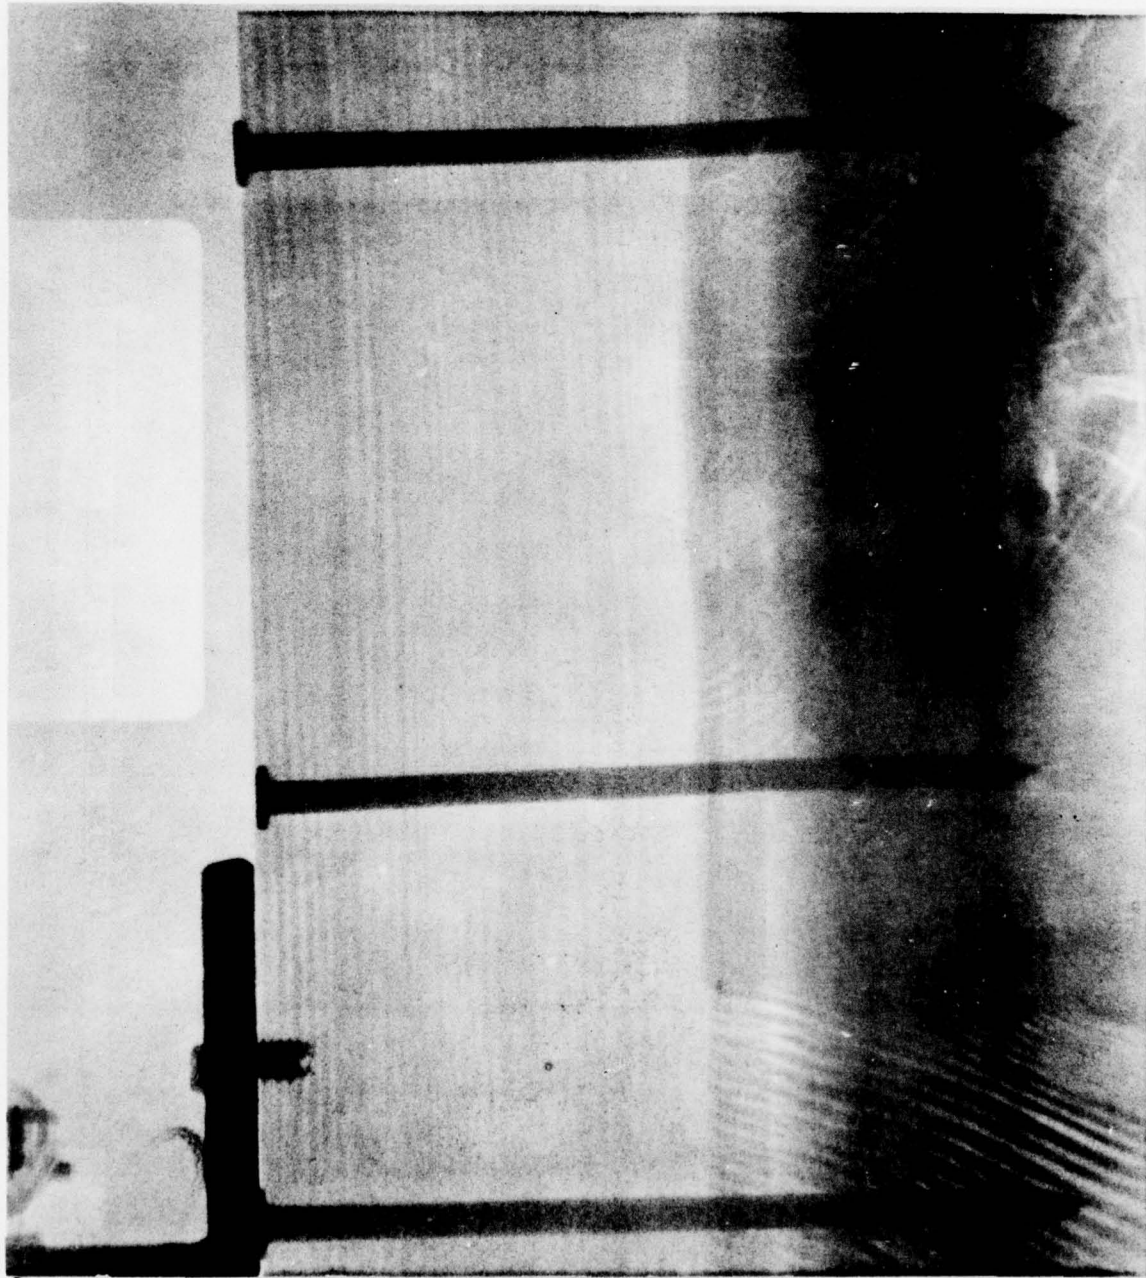
Nail distortion after 19 impacts. Permanent displacement equals 0.053 inch.

The X-Ray photographs of the specimen are shown as Figures 4 through 10. If the X-Rays are to be compared with Figure 2, the specimen in Figure 2 must be oriented so that the longitudinal direction of the simulated floor is vertical and the two nails in the same longitudinal plane of the cleat are above the third nail. The darker portions on the photograph are analogous to the ends of the simulated floor boards. Because the nails are not in the same horizontal plane, the nail that is closer to the film appears to be shorter and smaller than the other two nails. This appearance is due to the shadow effect produced by the X-Rays being emitted in a conical pattern and the nails in horizontal planes between the X-Ray emitter and the film.

Observe the distortion of the nails shown in Figures 4, 5, and 6. There is no observable distortion in the nails in Figures 4 and 5 but there is some distortion in the nails in Figure 6. As stated in Part II, the yield point corresponds to 0.05 inch displacement. Figure 5 represents the nail distortion at the yield point. Based on this information it appears that the yield point corresponds with the force required to bend the low carbon nail. (At this point the observation must be considered an hypothesis).

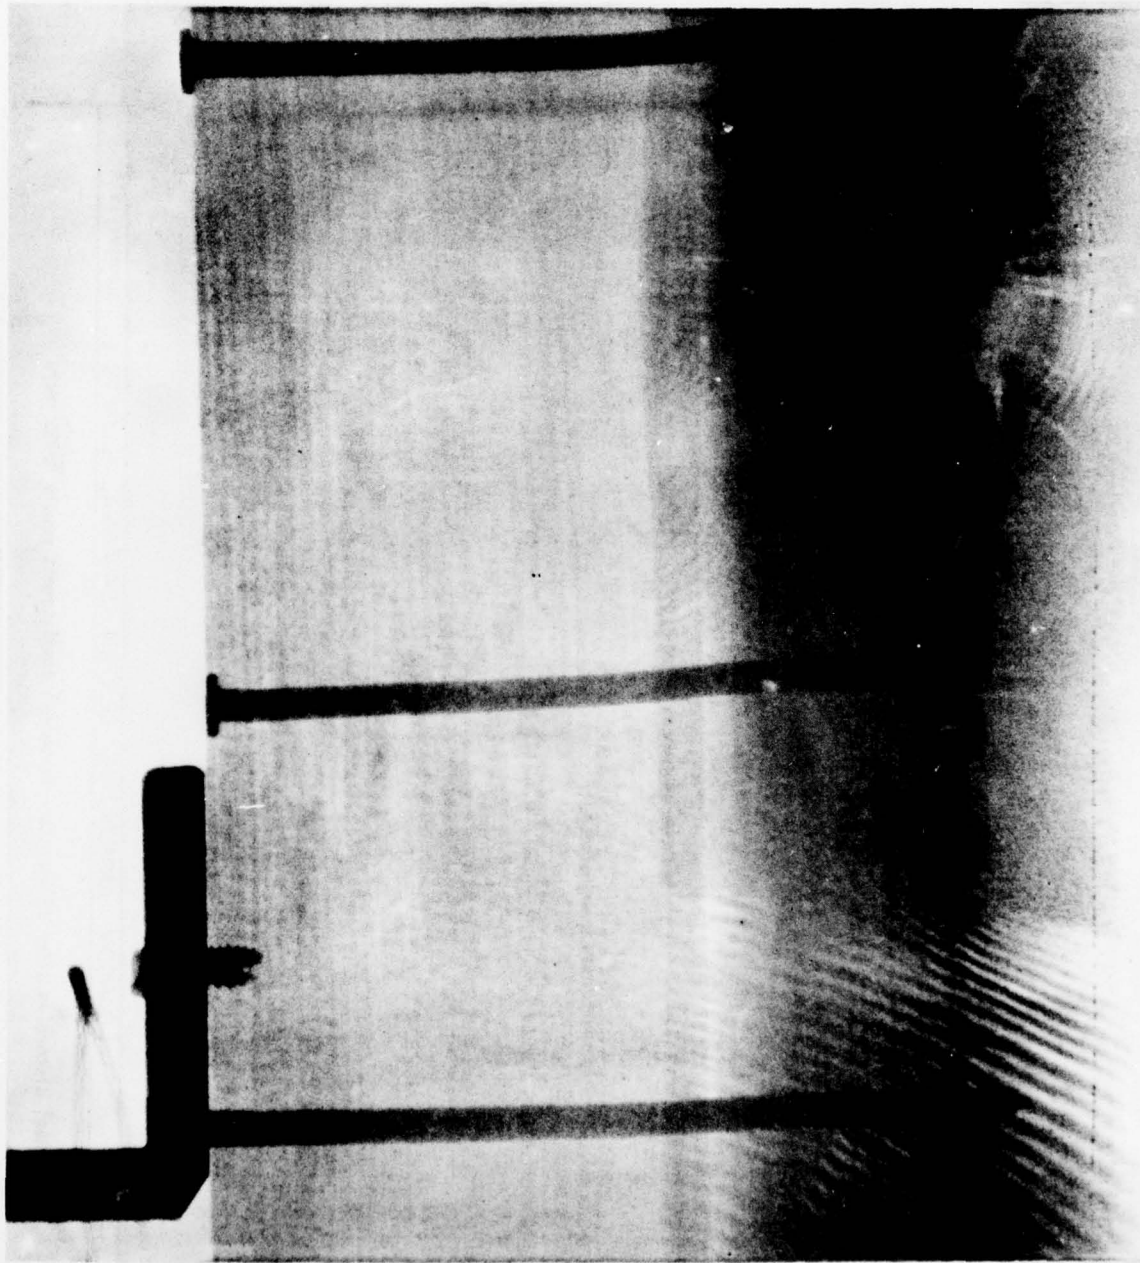
Figure 6 DARCOM AMMUNITION CENTER - SAVANNA, ILLINOIS November 1976

Nail distortion after 26 impacts. Permanent displacement equals 0.109 inch.

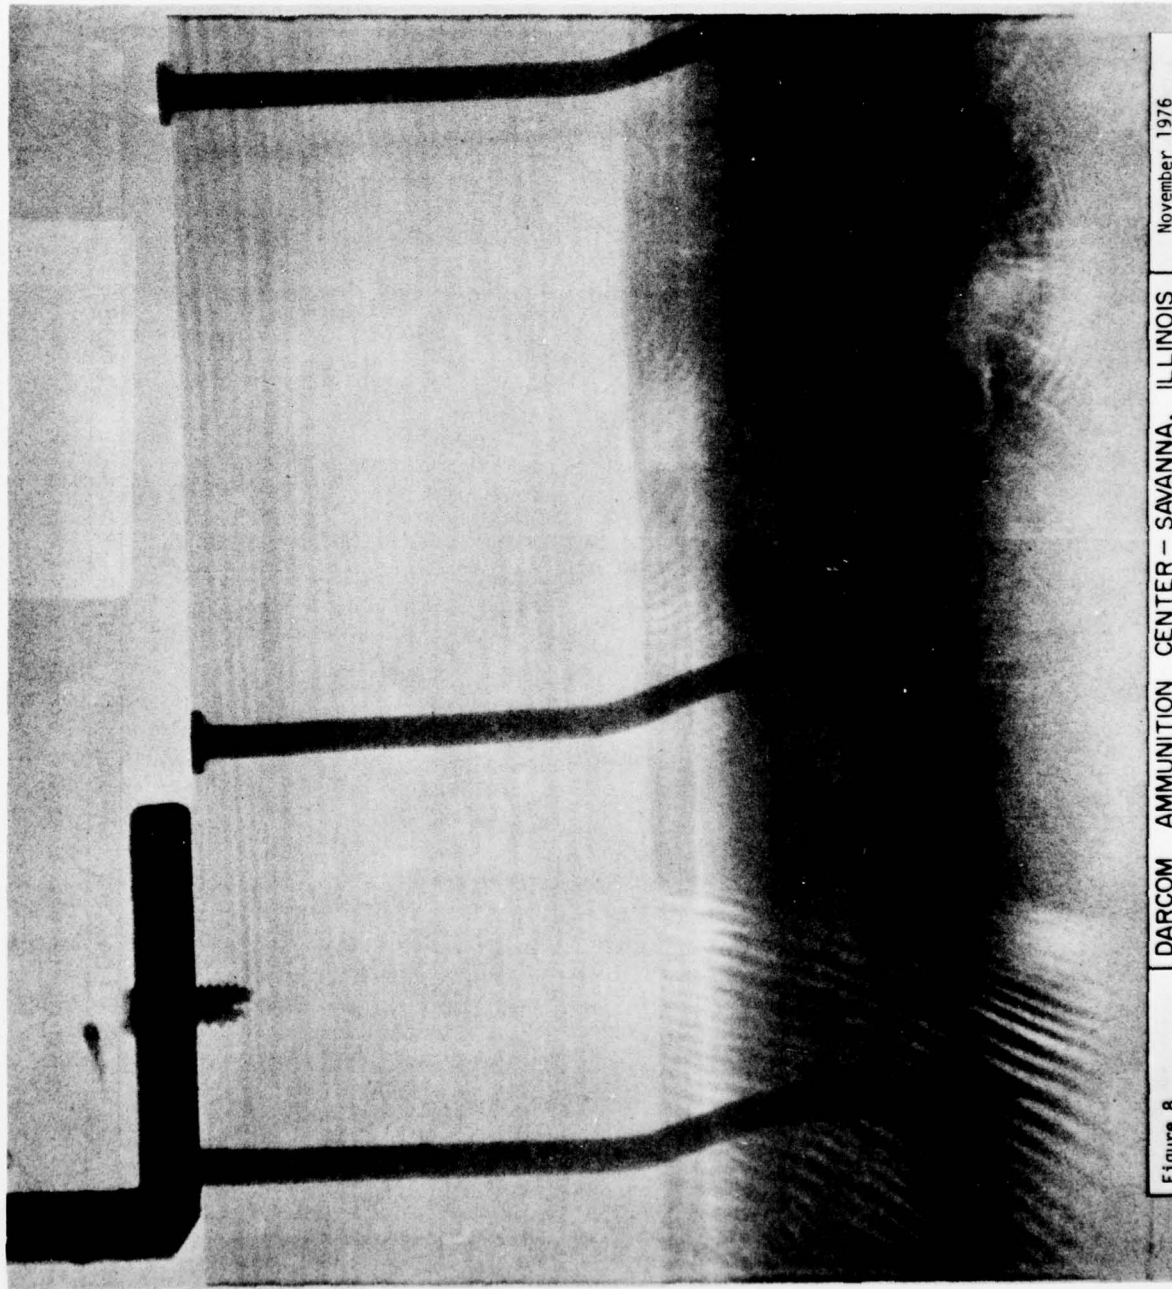
Figure 8

Nail distortion after 39 impacts. Permanent displacement equals 0.366 inch.

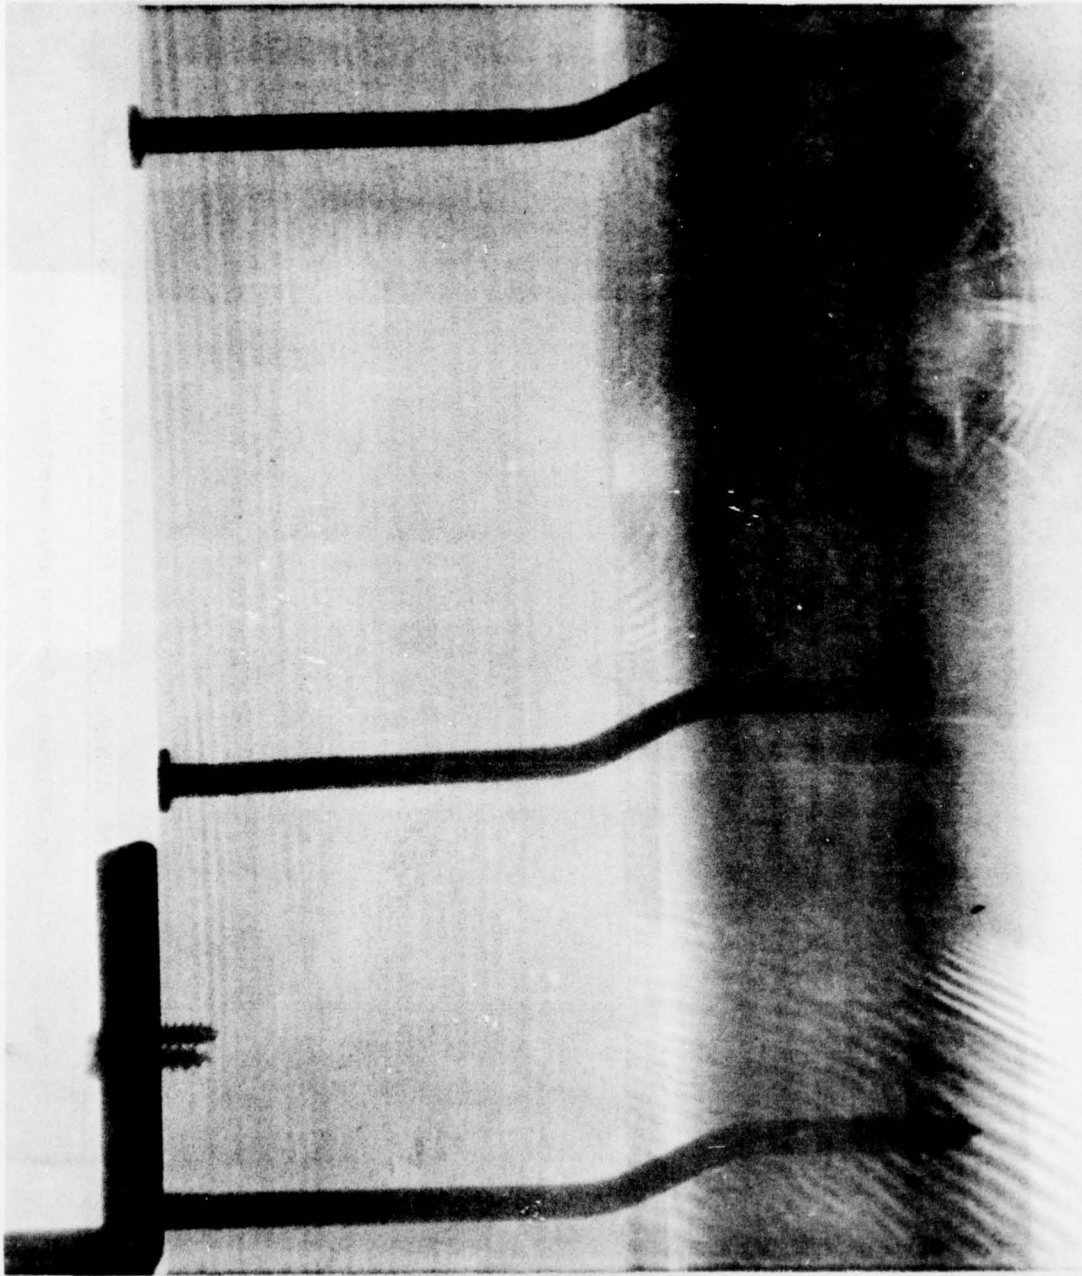
Figure 9	DARCOM AMMUNITION CENTER - SAVANNA, ILLINOIS	November 1976
Nail distortion after 41 impacts. Permanent displacement equals 0.467 inch.

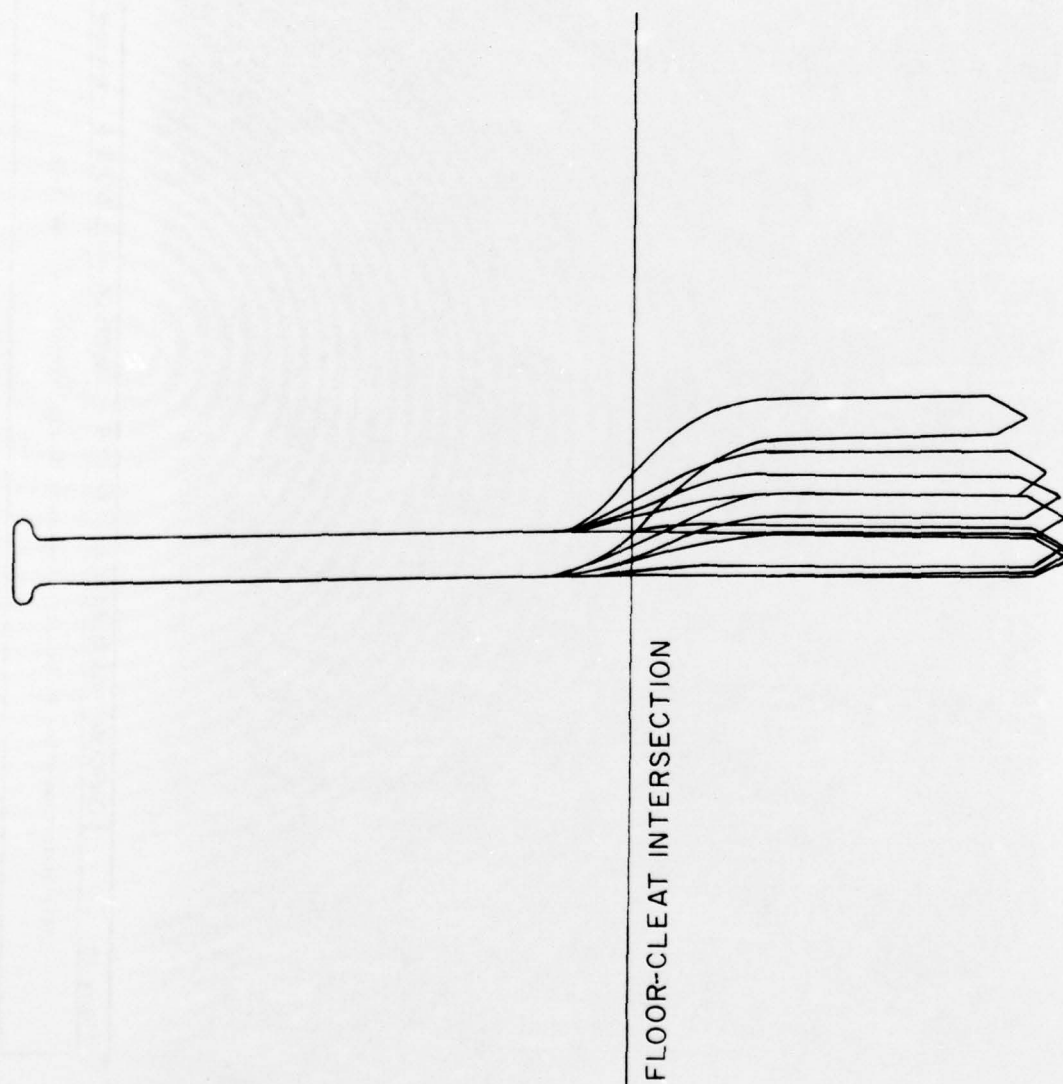
FIGURE II. DISTORTION OF A LOW CARBON NAIL IN A JOINT SUBJECTED TO DYNAMIC FORCES

the test the top board or cleat moved and not the floor as indicated in this Figure. However this arrangement has the advantage of showing the nail distortion and change in depth of penetration with the increase in permanent displacement.

By superimposing the seven X-Rays and maintaining the position of the nail head, the results are as shown in Figure 11. Note that during
